**CONSENT ORDER
ISSUED UNDER THE
WATER POLLUTION CONTROL ACT
WEST VIRGINIA CODE, CHAPTER 22, ARTICLE 11**

TO: Mountain Valley Pipeline, LLC
Attn: Robert J. Cooper
Senior Vice President, Engineering and Construction
625 Liberty Ave, Ste 1700
Pittsburgh, PA 15222

DATE: April 19, 2019

ORDER NO.: 8951

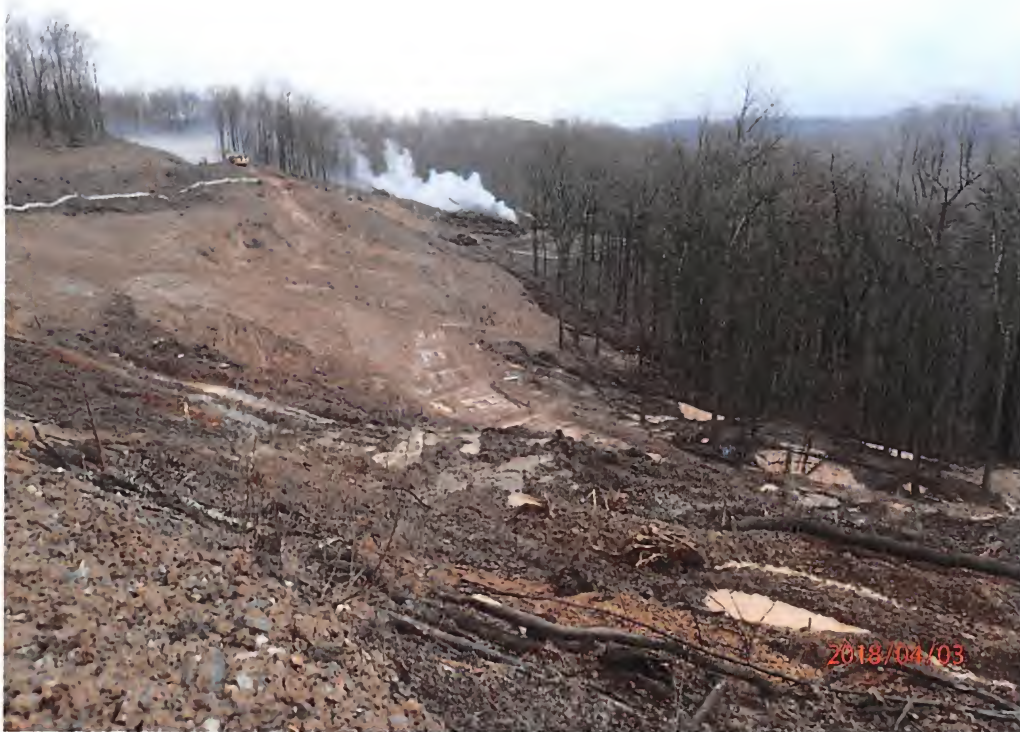
Disturbed area near the reported slip area.

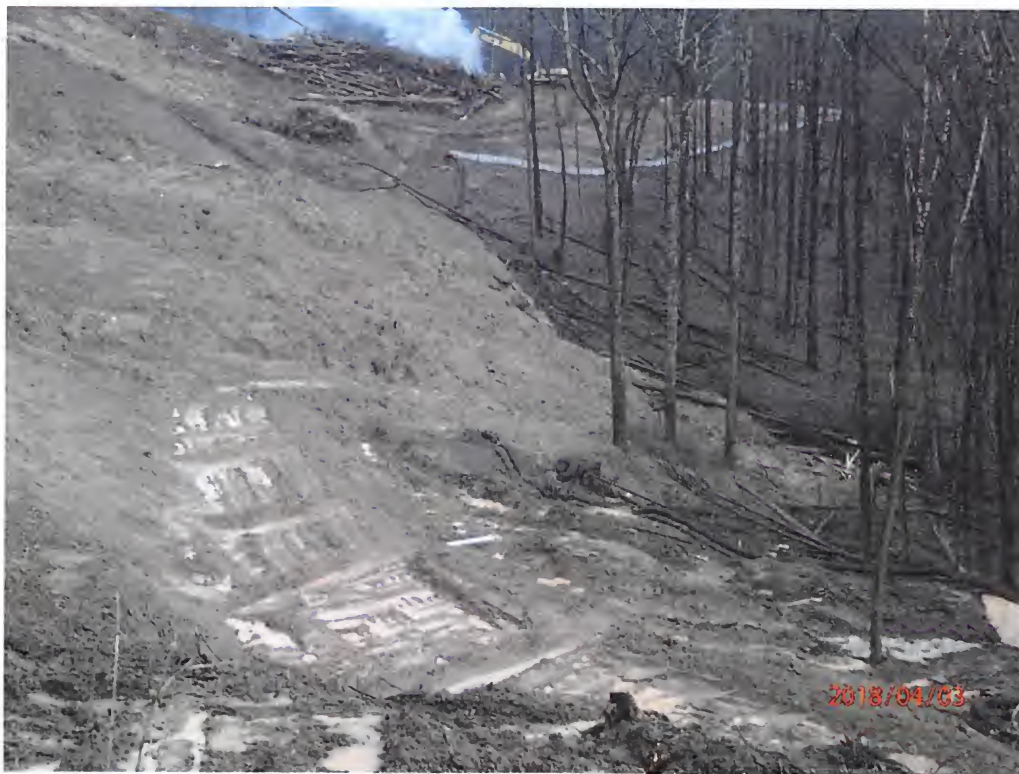
Reported slip area near Bradshaw Compressor Station.

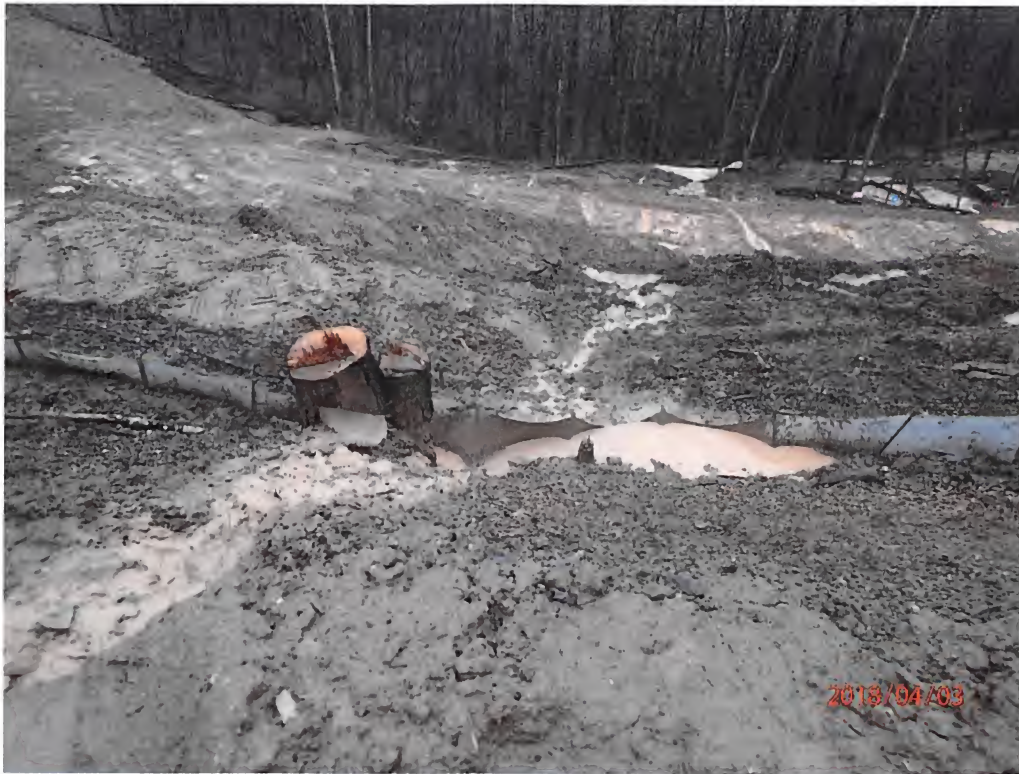
Concentrated flow eroding slope near slip.

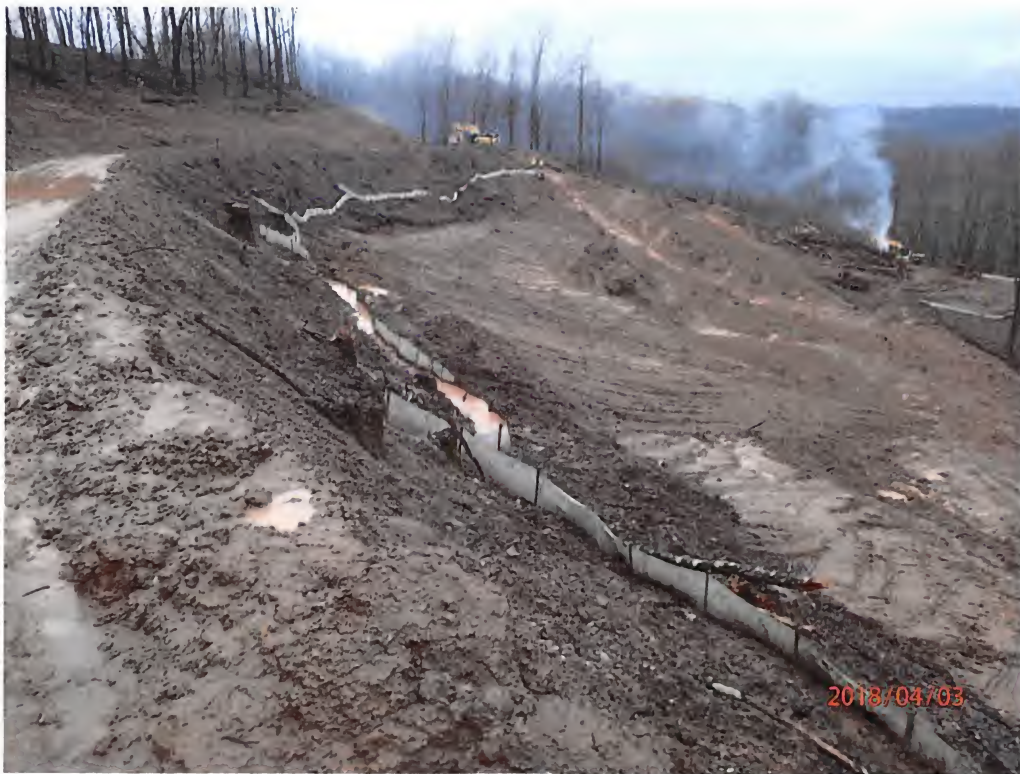
Hillside above slip near Bradshaw Compressor Station.

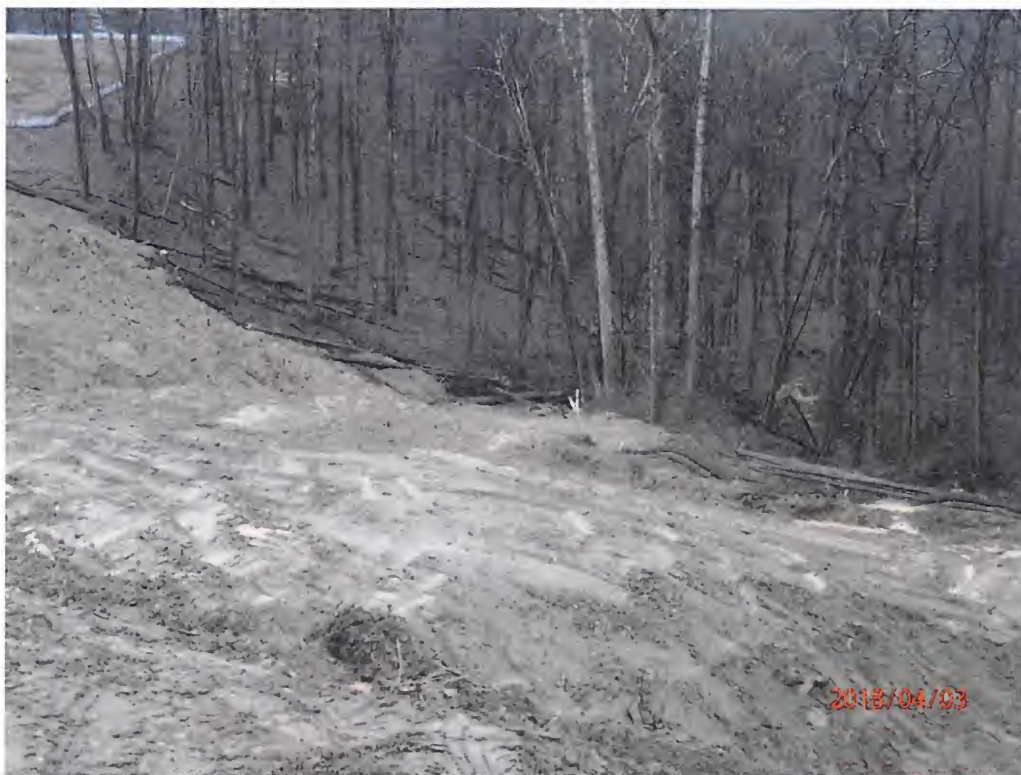
Slope above slip area.

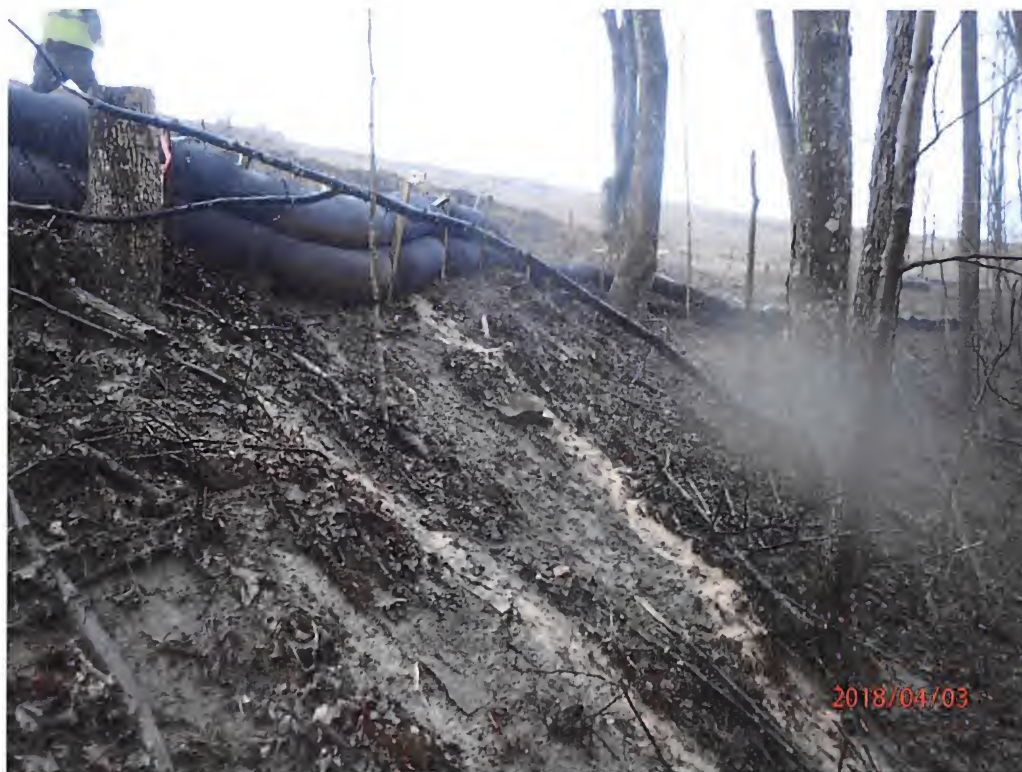
Sediment laden water leaving site at Bradshaw Compressor Station.

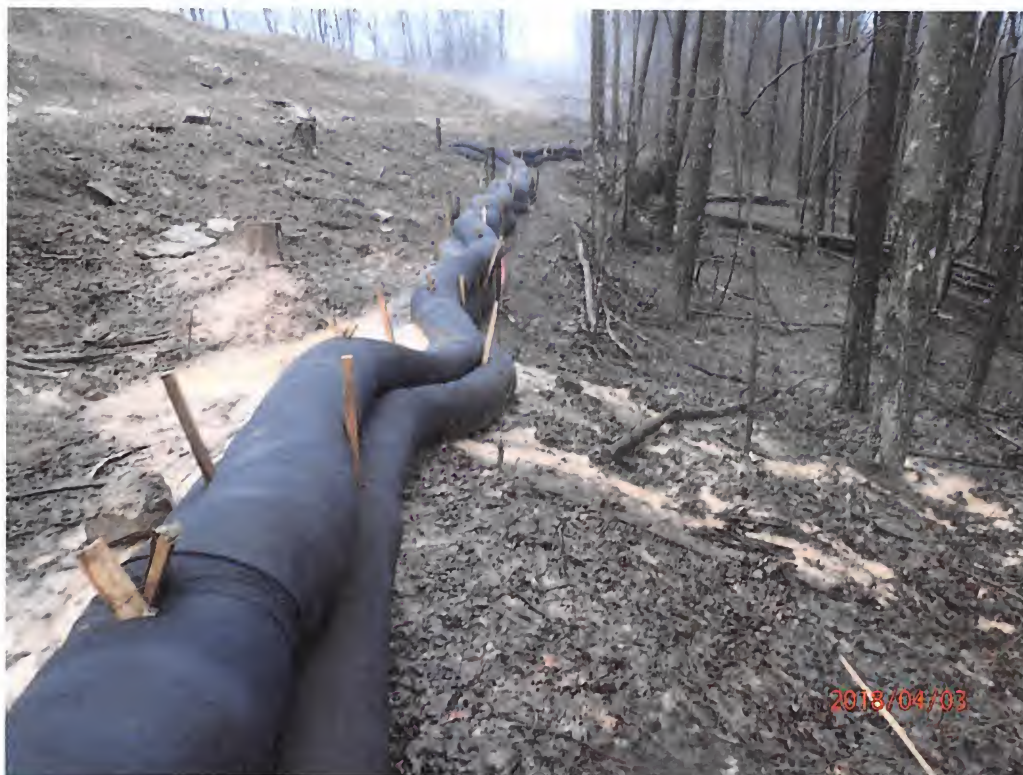
Second site of sediment laden water leaving site at Bradshaw Compressor Station.

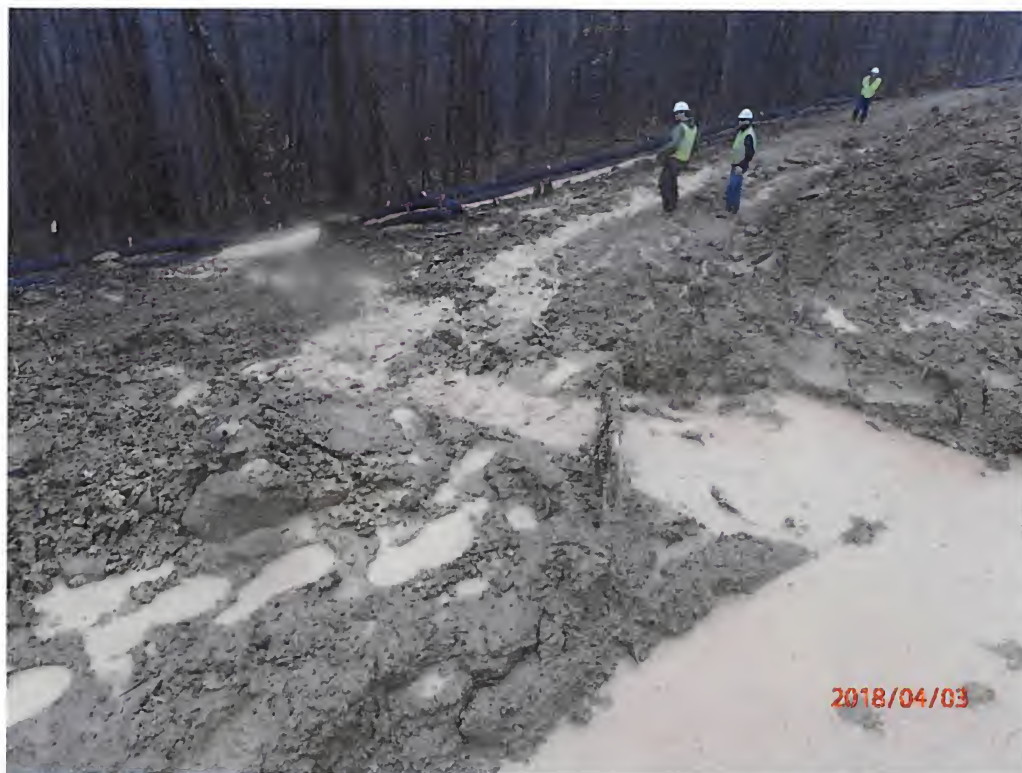
Third site of sediment laden water leaving site at Bradshaw Compressor Station.

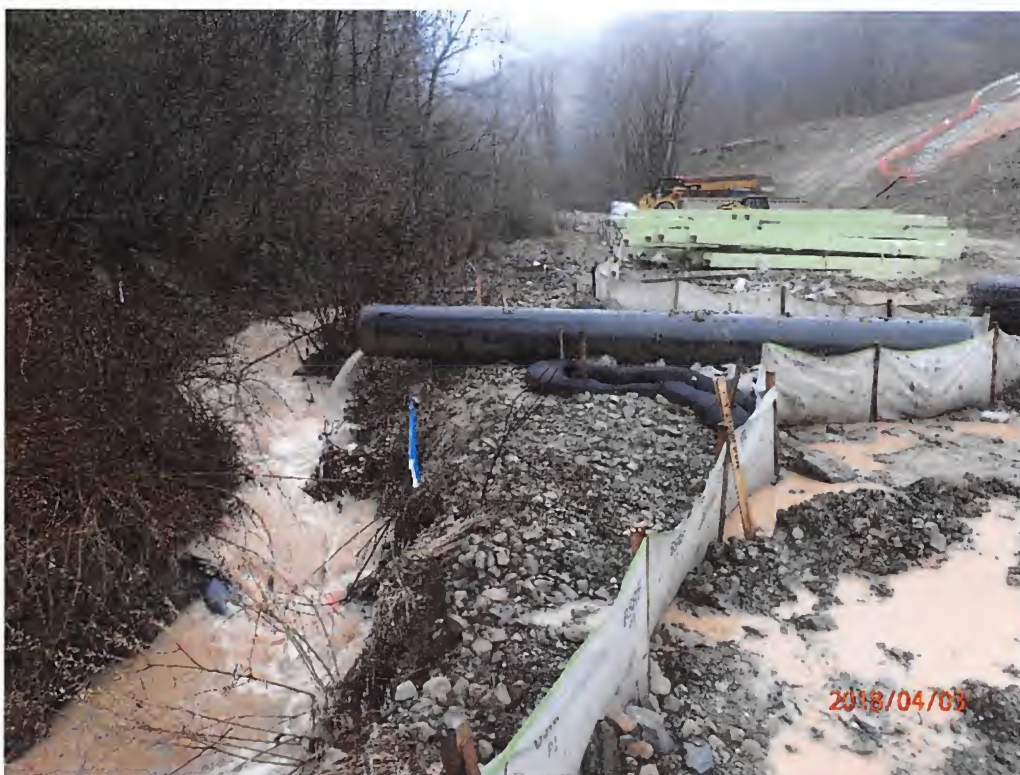
UT of Mobley Run near Mobley Compressor Station.

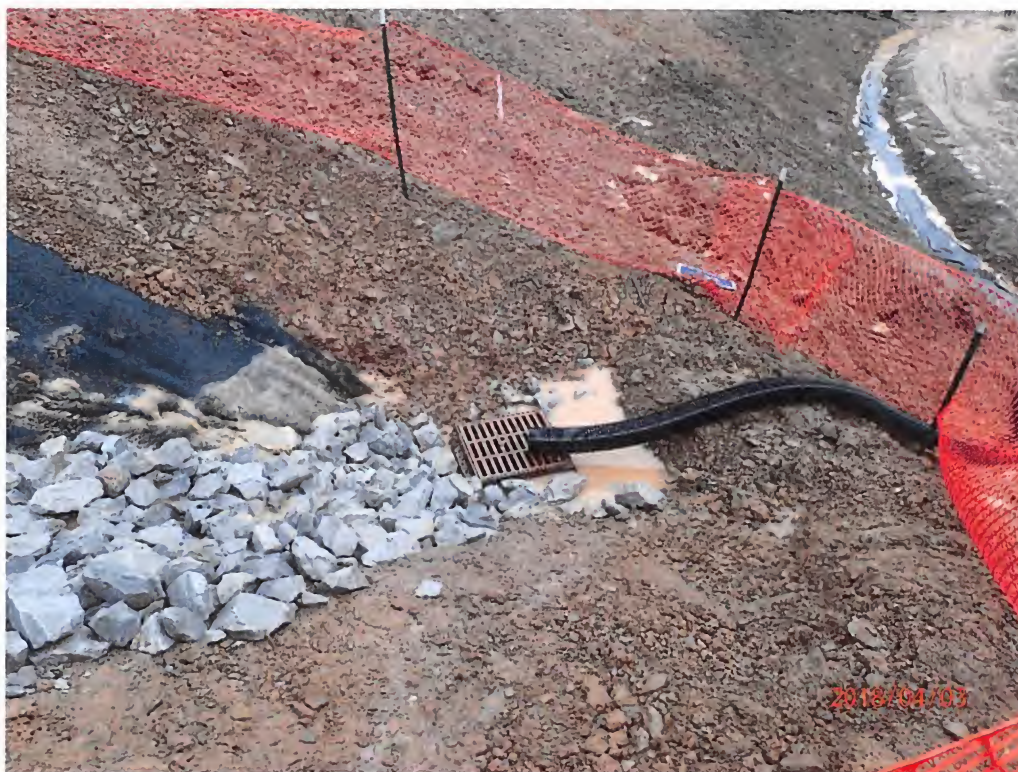
Unprotected drop inlet at Mobley Compressor Station.

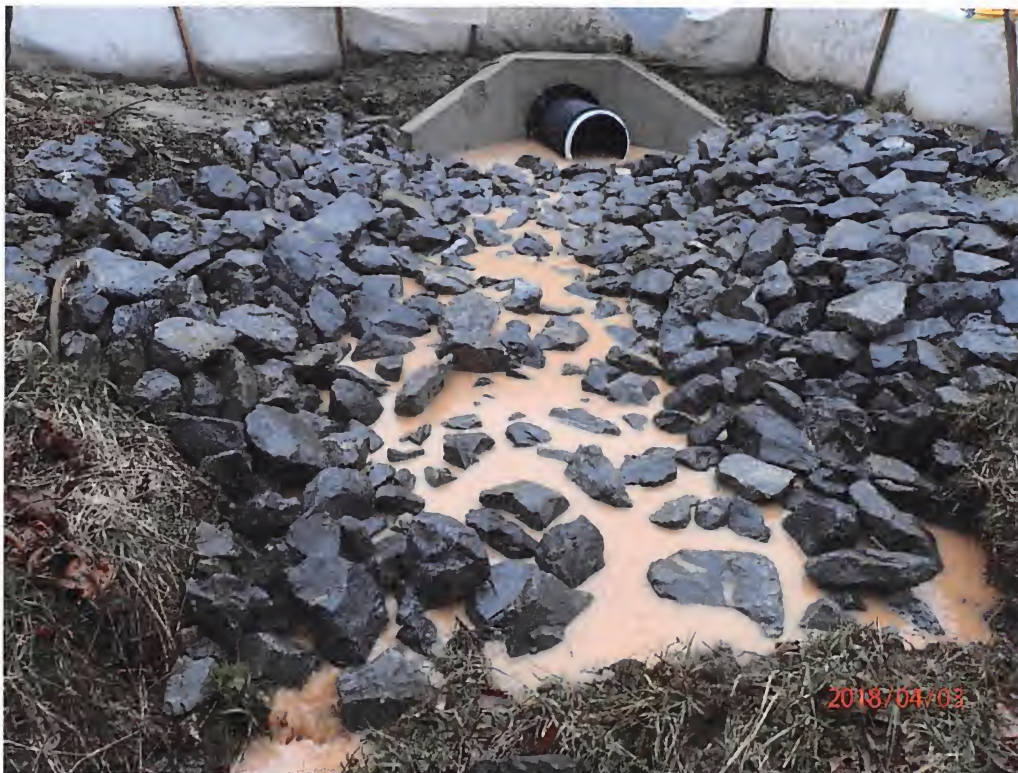
Sediment laden water leaving site into UT of Mobley Run.

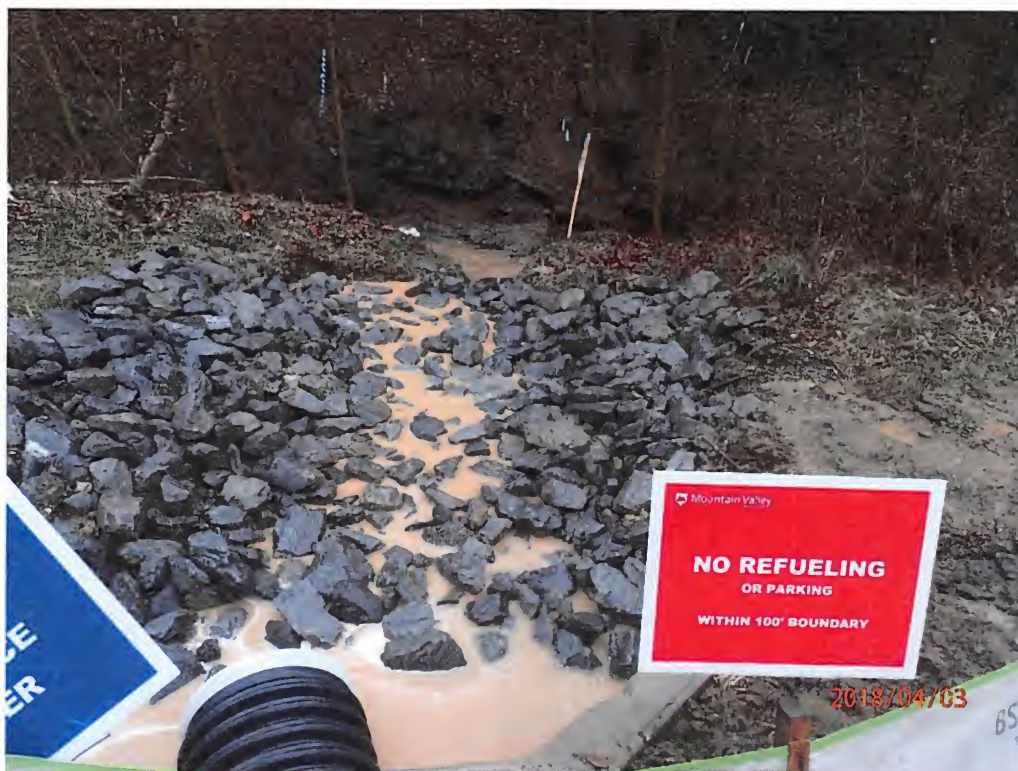
Sediment laden water leaving site into UT of Mobley Run.

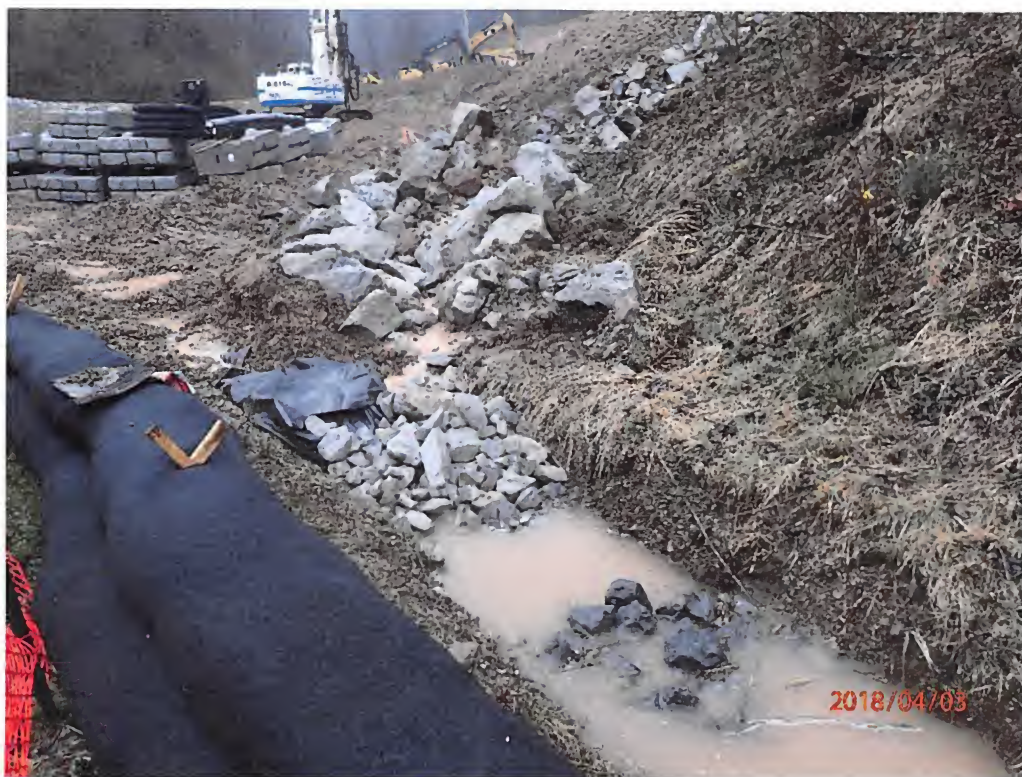
Sediment laden water leaving site through drop inlet.

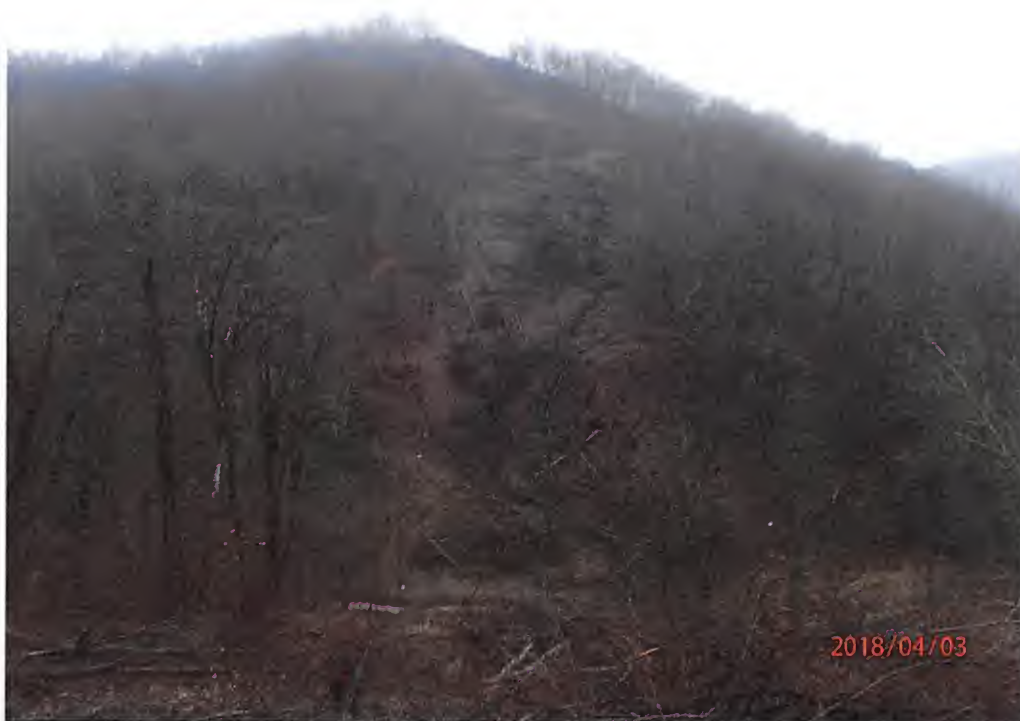
Line clearing off North Fork Road.

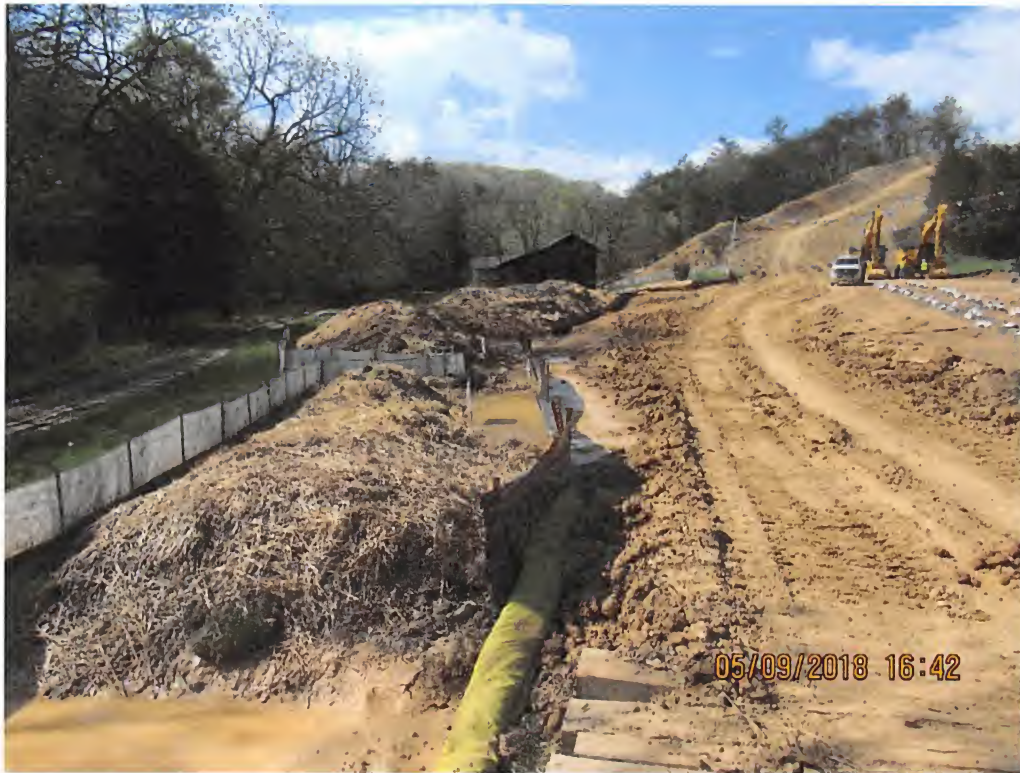
Photo 1: Delineation of topsoil stockpiles from subsoil with black silt fence and path to sump prior to stream.

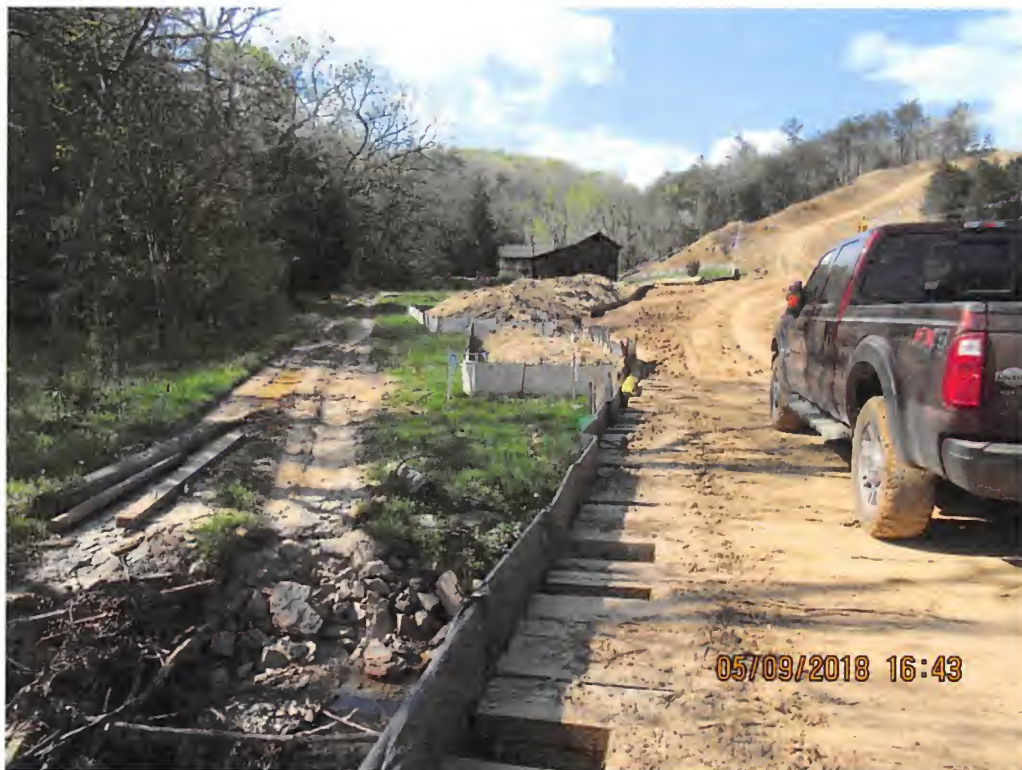
Photo 2: Topsoil delineation, sump, perimeter fencing and vegetative buffer prior to stream.

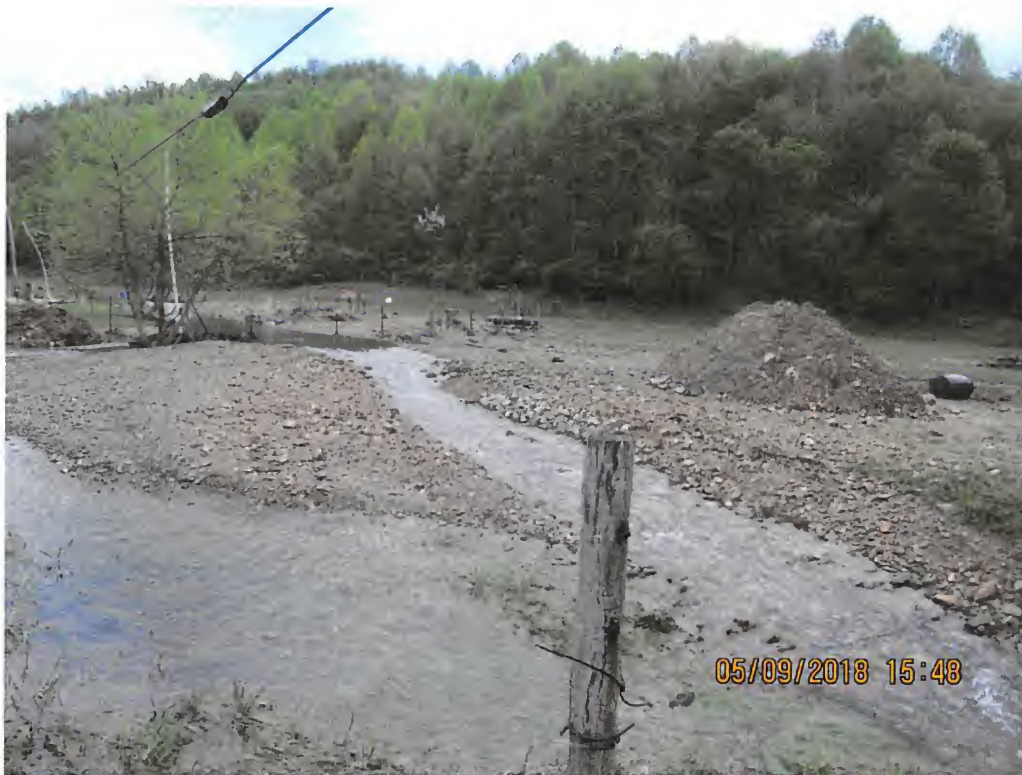
Photo 3: station 10146+32, sheet 9.35 - stream has been partially returned to channel. Rock/soil pile resulted from landowner removing debris to restore to channel.

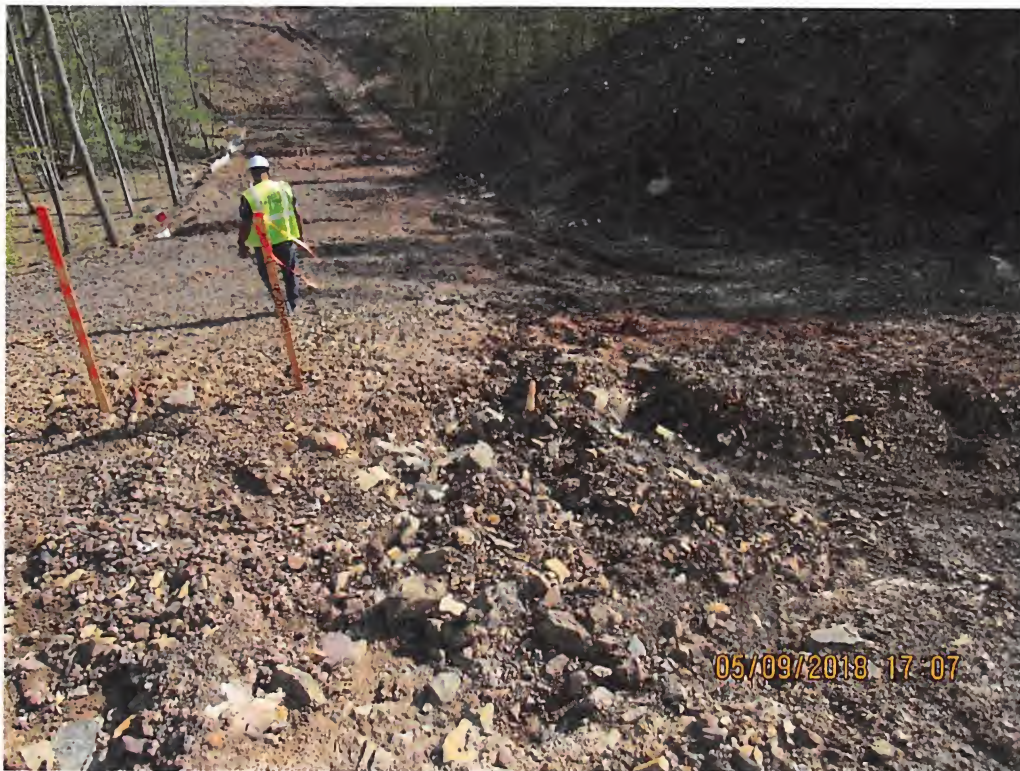
Photo 4: Downslope view of site of sediment laden water leaving site- erosion gullies observed on slope. (view south)

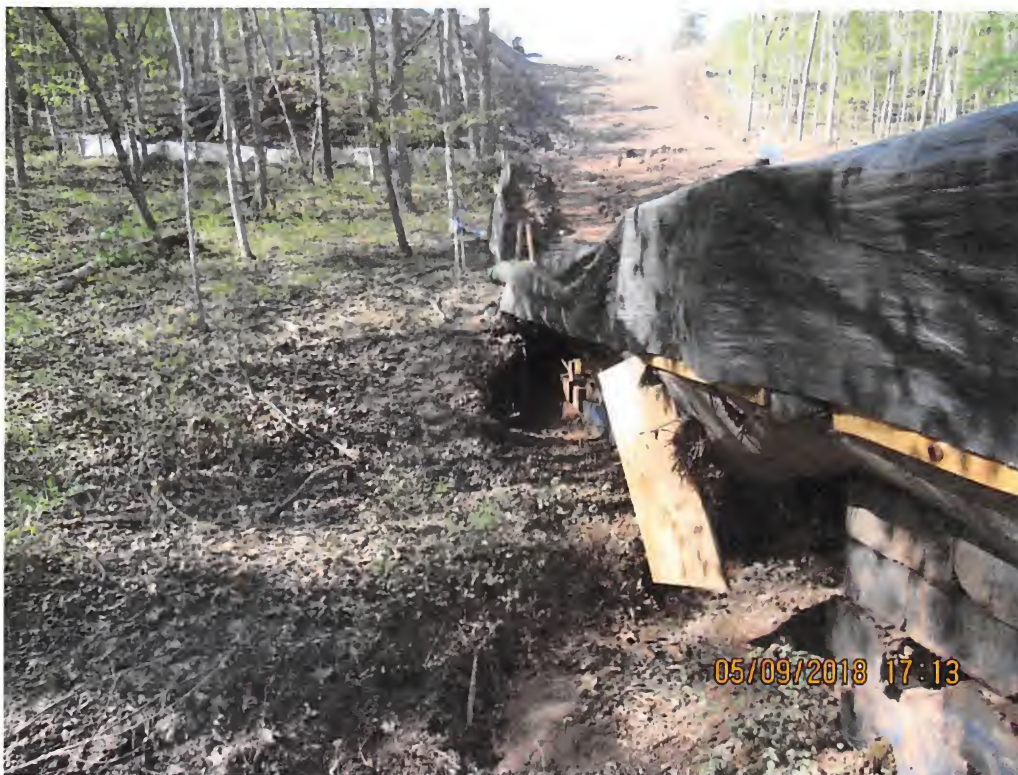
Photo 5: Stream crossing where sediment laden water left site after controls failed at stream S-IJ65 (view north). Additional controls added prior to re-building of bridge.

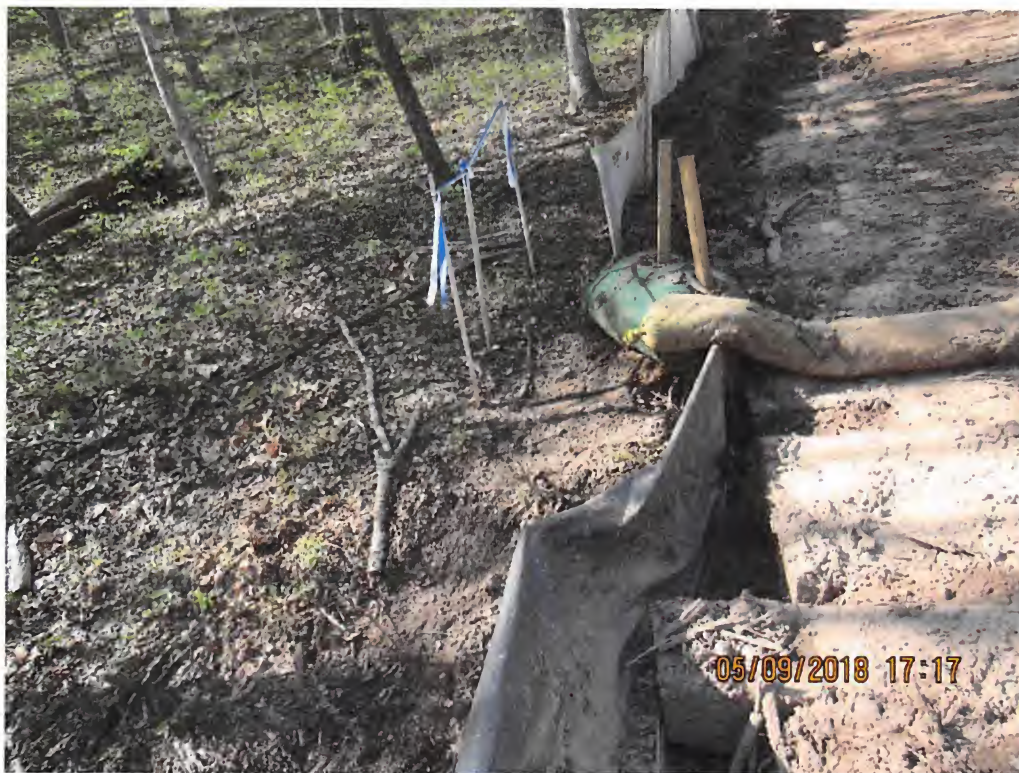
Photo 6: Location of control failure and breach allowing sediment laden water to leave site. Additional control (larger silt sock) added prior to bridge re-build.

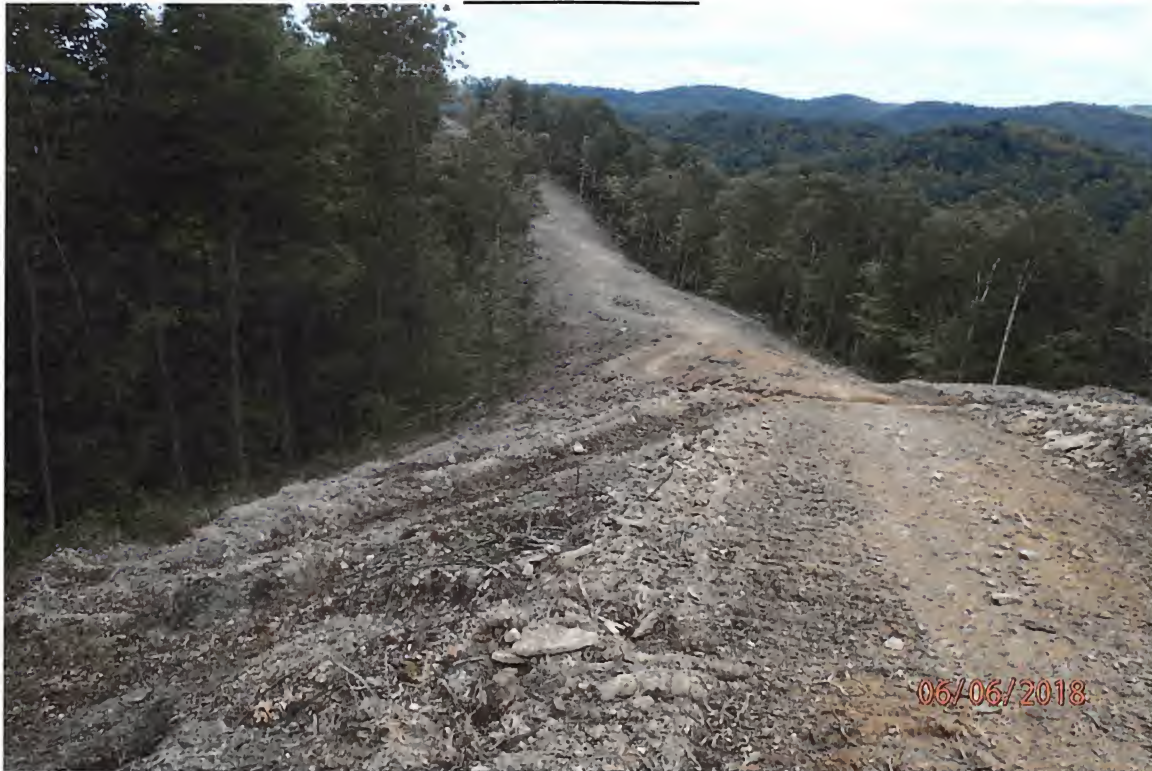
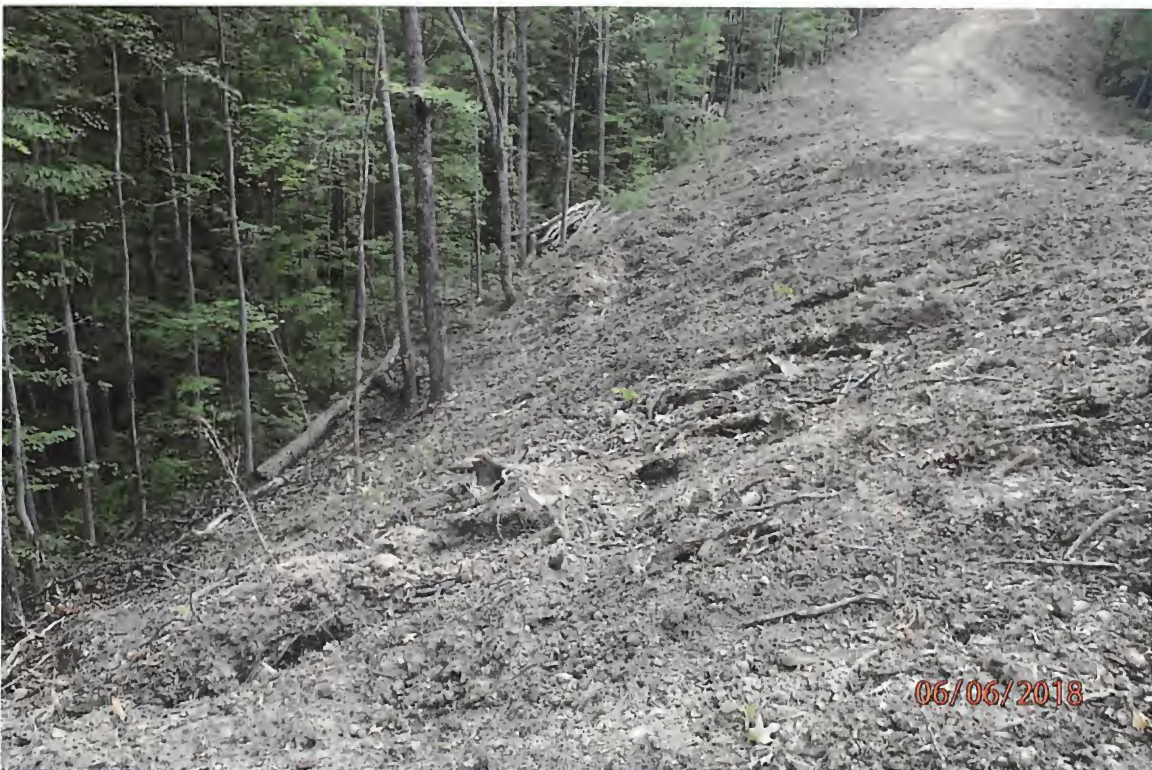
Areas of the project that have been cleared to mineral soil and BMPs are not in place as indicated in the SWPPP.

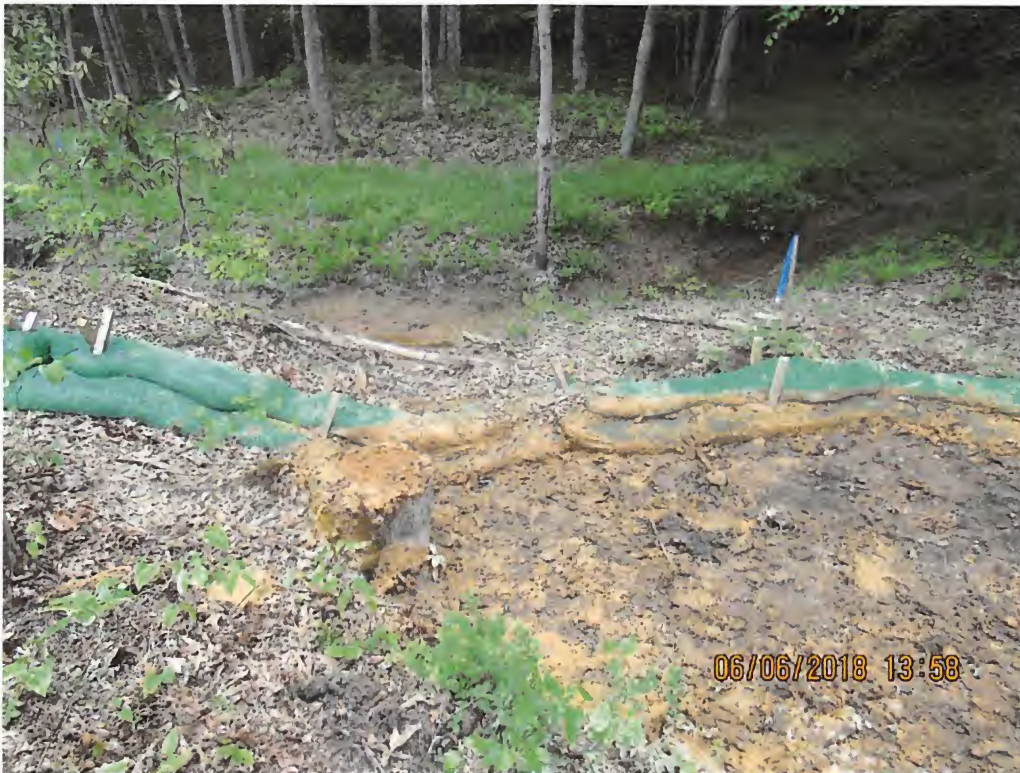
Photo 1: Station 6782+00 control failure repair but additional controls not added.

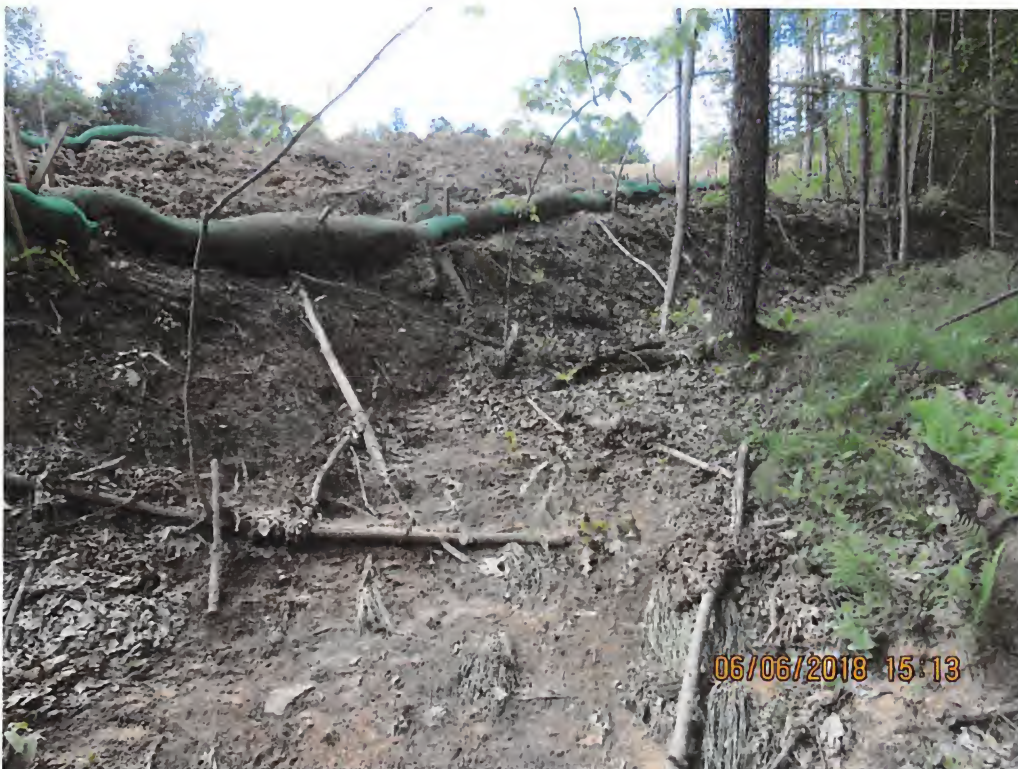
Photo 4: Control failure at station 6812+58 allowing sediment laden water to leave site.

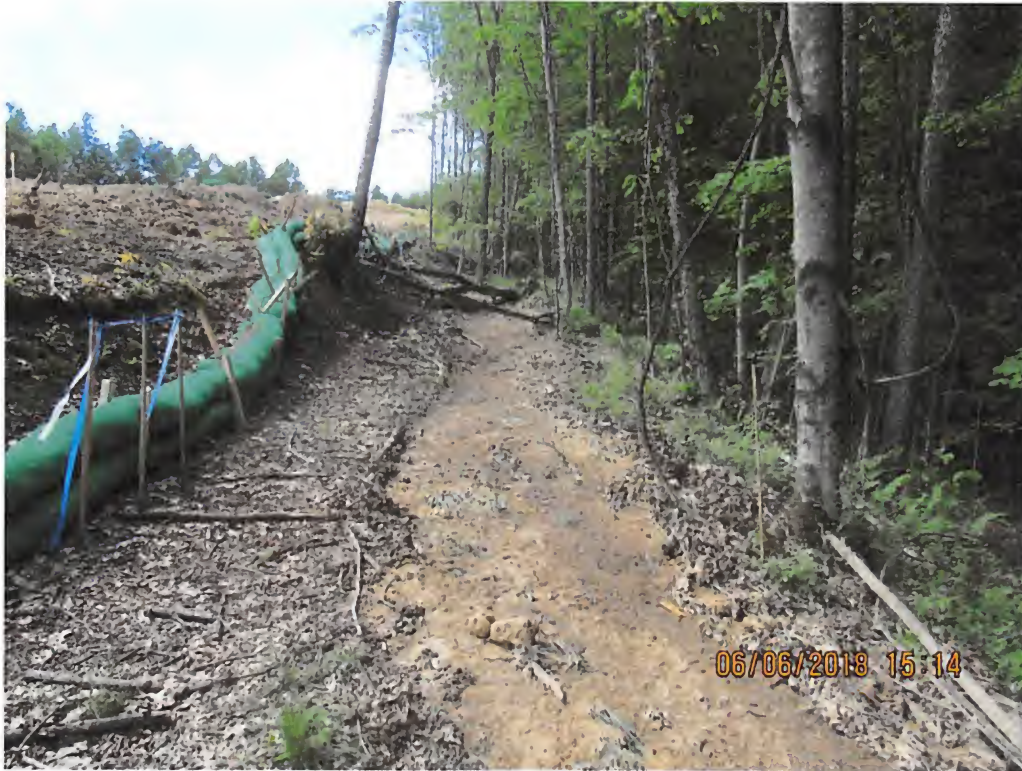
Photo 5: Scoured path from control failure at station 6812+58.

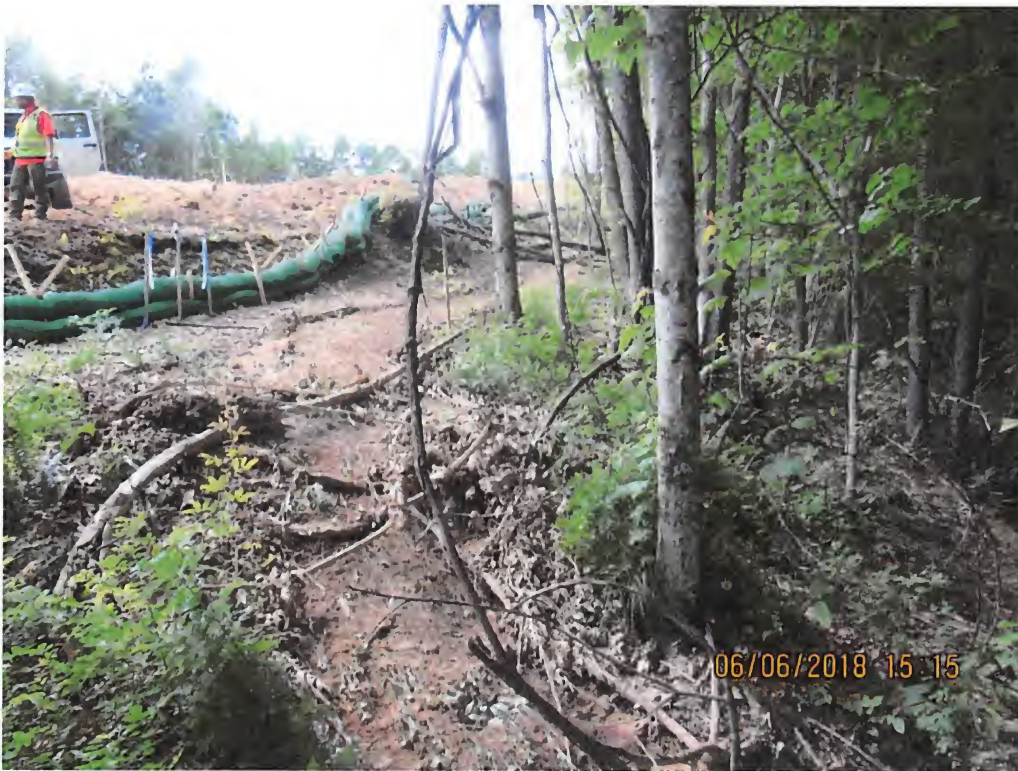
Photo 6: Continued scoured path from control failure at station 6812+58.

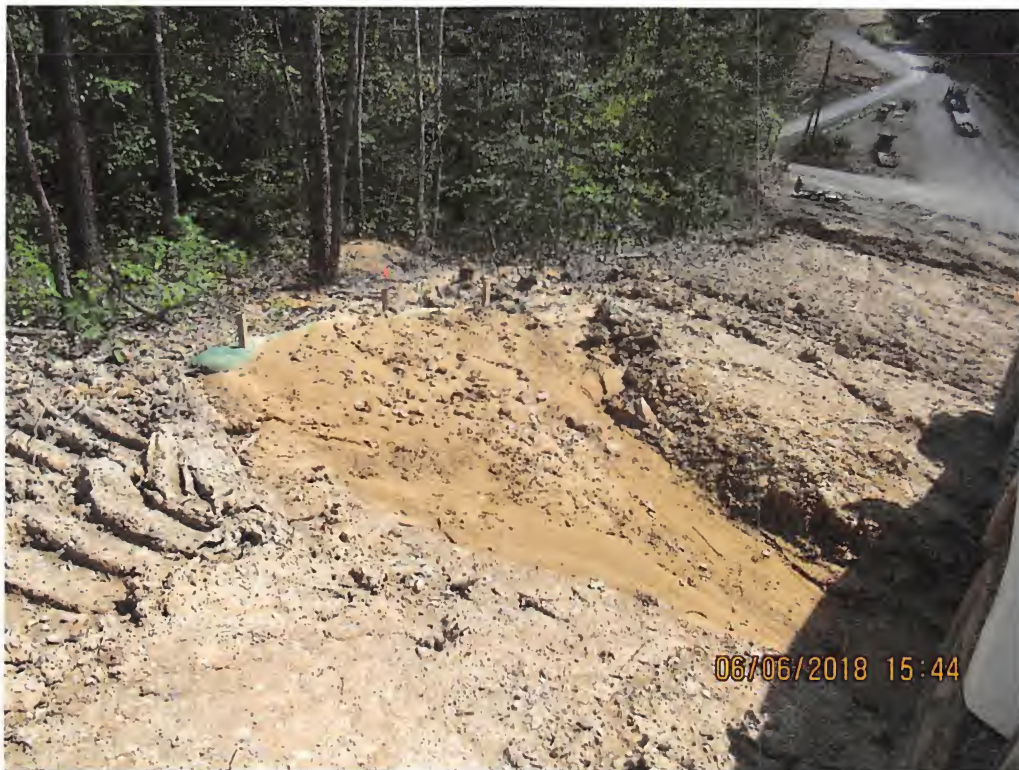
Photo 8: Control failure near station 6854+00 where sediment laden water left site.

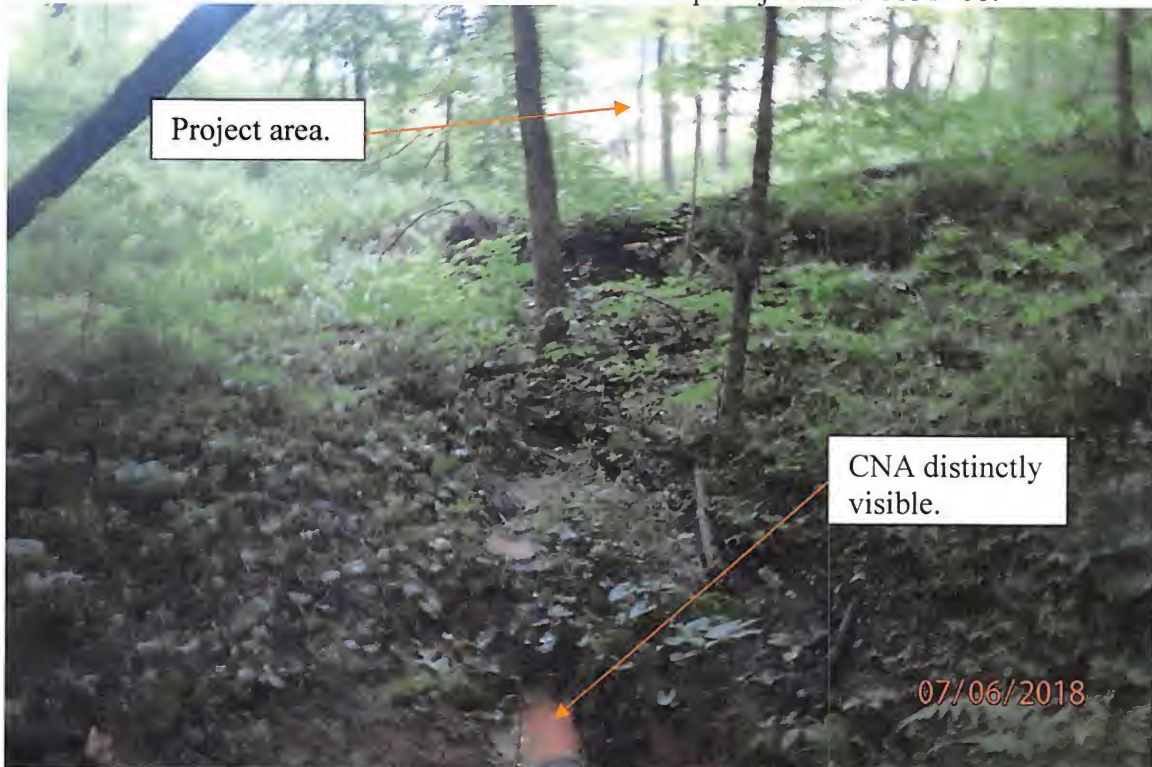
Sediment laden water in UNT Meathouse Fork that originates from site.
